Lessons learned from failure: EPS geof foam

What have we learned from and about geof foam failures?

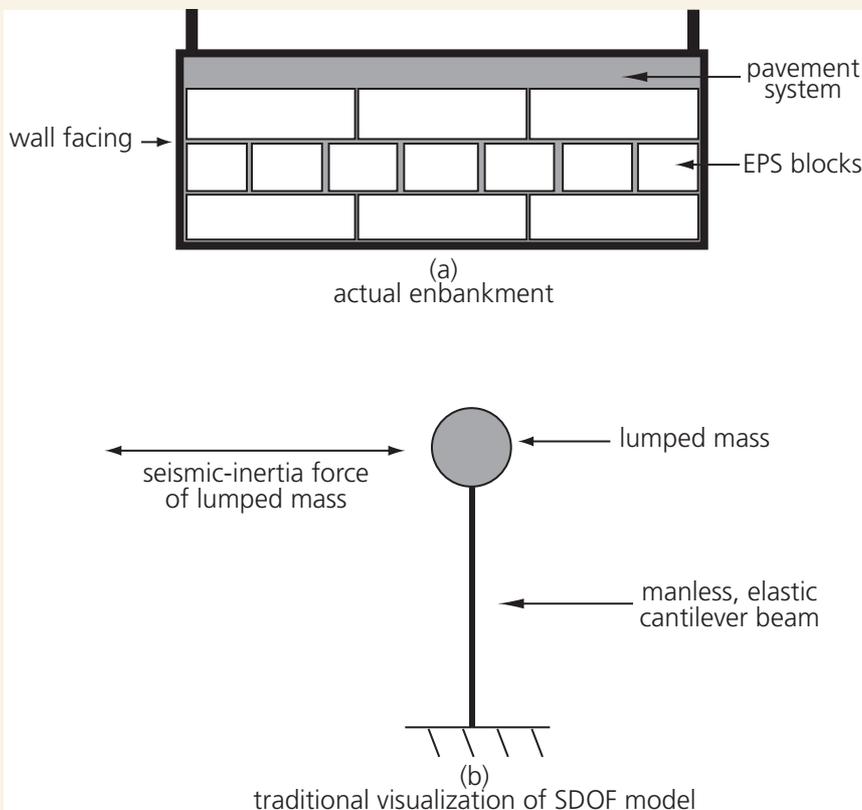
Figure 1. Seismic analysis model for an EPS geof foam embankment.

For seismic analysis and design, EPS-geofoam fills are typically modeled as a single-degree-of-freedom (SDOF) system as shown in **Figure 1** because of their top-heavy nature (Horvath 1995, Nomaguchi 1996). For the historically more common case of an embankment wider than it is high, the primary mode of displacement and deformation as a result of the horizontal seismic-inertia force on the lumped mass (**Figure 1a**) is flexible in nature and in the form of lateral sway of the entire embankment as shown in **Figure 2a**. Traditional seismic analysis and design methodologies for EPS geofoam fills are based on this assumption (Horvath 1995, 2004).

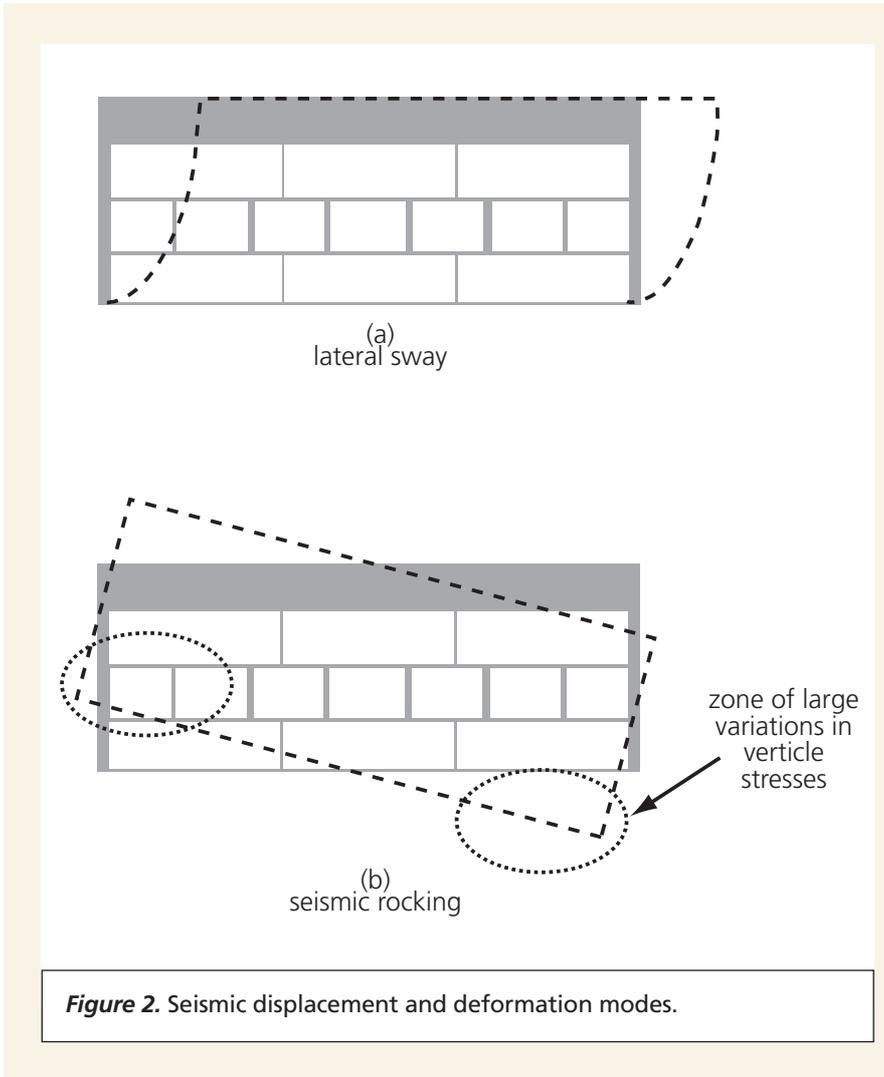
Figure 2. Seismic displacement and deformation modes.

However, during preliminary design of the Contract C09C2 embankments in early 2001 the project design team hypothesized an additional displacement/deformation mode in the form of rigid-body rotation of the entire embankment. This mode, which is shown in **Figure 2b** and was ultimately given the name seismic rocking, involves rigid-body rotation of the embankment in the plane of the figure about an axis perpendicular to the figure.

Although these references did not elaborate on or explain the cause of these failures, it was quite apparent to the Contract C09C2 design team that the observed results were due to the previously unknown behavioral mode of seismic rocking. What happens during seismic rocking is that the lowermost/outermost portions of an assemblage of EPS blocks (see the highlighted areas in **Figure 2b**) are subjected to relatively large cyclic changes in vertical normal stresses due to the rocking motion. These stress changes are due to what is referred to as the *M-c-on-I* (*Mc/I*) effect. The moment referred to in this case is that caused by the seismic-inertia force shown in **Figure 1b**. This moment acts within the plane shown in this figure about an axis perpendicular to this figure and is obviously largest at the very bottom of the embankment. Note that these dynamic stress changes must be added vectorially to the usual vertical stresses within an embankment due to gravity loads. Under seismic rocking, unless the EPS has been designed to withstand the combined gravity + seismic compressive stresses, it will be pounded beyond its yield range into a stress-strain region of large plastic strains that are largely unrecoverable. Each cycle of seismic load only adds to the accumulated non-recoverable strain.
